# Geomorphology

## Collapse of the Pilcomayo River

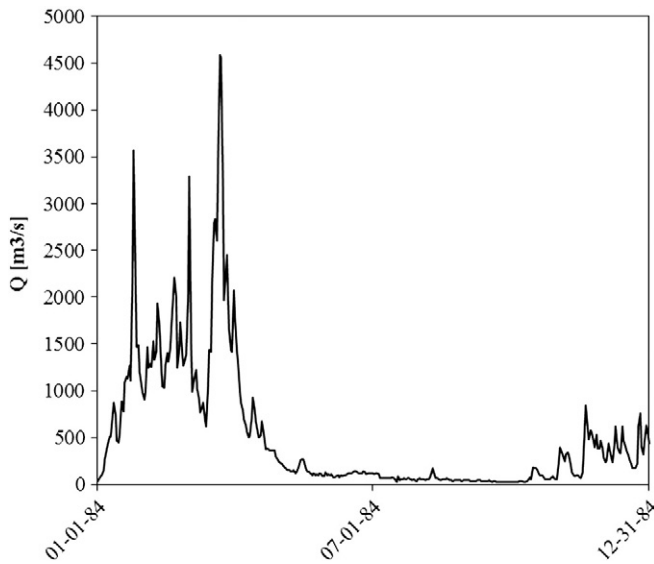
Fig. 2. Hydrograph of the year 1984 at station 2.

As an example, Fig. 2 is the annual hydrograph of the humid year 1984 at station 2, located 180 km downstream of station 1 (Fig. 1), with a catchment area of 96,000 km<sup>2</sup>. Within the 3-month rainy season from January to March, usually several peaks easily occur and exceed 1500 m<sup>3</sup>/s every year, like in the year 1984. At gauging station 2, the maximum recorded discharge in 30 years was 5500 m<sup>3</sup>/s and the minimum was 3.2 m<sup>3</sup>/s.

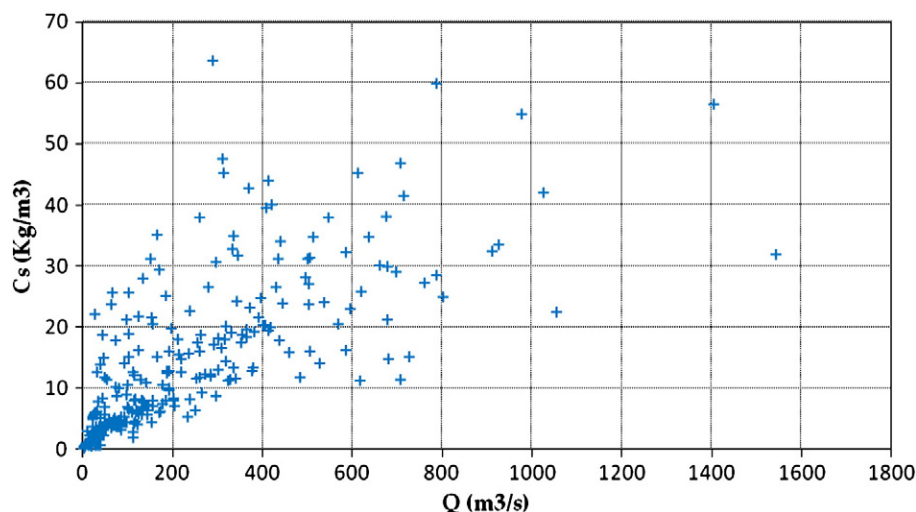
Fig. 3. Concentration of suspended sediment  $C_s$  versus discharge  $Q$  for station 2 from September 1, 1972 until August 31, 1973. Non-linearity and hysteresis are derived from this plot.

Thirty years of data at station 2, which include data not published by Guyot et al. (1990), give a mean suspended sediment load of  $140 \cdot 10^6$  tons per year, one of the largest in the world. Some 89% of this huge amount is in the range of silt and clay, which should be considered wash load – the remaining 11% is fine grained sand. The median size  $D_{50}$  of this wash load is a little larger in the dry season ( $6 \mu\text{m}$ ) than in the rainy season ( $4 \mu\text{m}$ ). The ratio of total sediment load  $Q_s$  and total runoff  $Q$  gives a yearly mean suspended sediment concentration  $C_s$  of 15.2 g/l at station 1. This figure is not constant throughout the year, but non-linearity is remarkable because a concentration as low as 0.01 g/l may occur in the dry season whereas the highest record in the rainy season reaches more than 60 g/l. The correlation between  $C_s$  and discharge  $Q$  is quite weak, anyway. For example, the daily data for one whole year at station 2 (Fig. 3) show a maximum  $C_s$  of 63.5 g/l when  $Q$  was below  $300 \text{ m}^3/\text{s}$ , whereas for the maximum  $Q$ , above  $1500 \text{ m}^3/\text{s}$ ,  $C_s$  was 32 g/l, just half of its maximum. The correlation slightly improves by computing concentration

for sediment particles larger and smaller than 0.062 mm separately, resulting fitting equations  $C_s = 0.45 \cdot Q^{0.29}$  and  $C_s = 0.12 \cdot Q^{0.82}$ , respectively. Another feature of the data is that a pattern of high sediment concentrations in advance of high discharges in the rising limbs is sometimes observed (not always) when comparing the sediment and flow hydrographs.

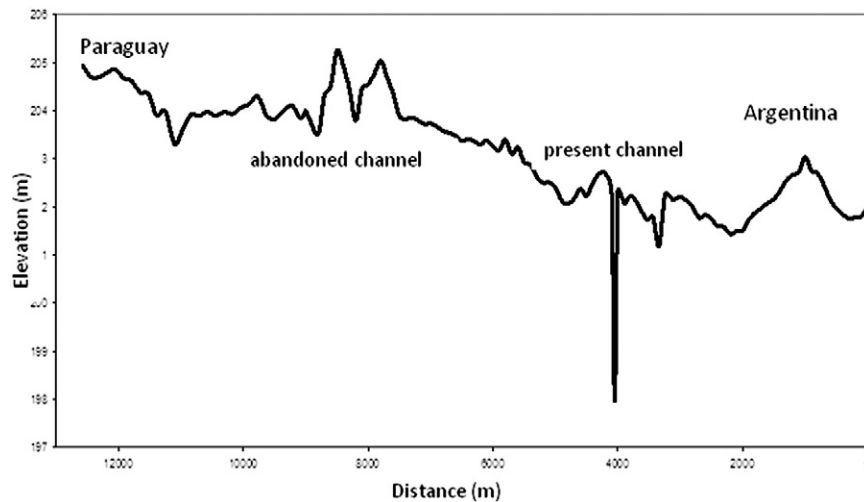
Fig. 4. Cross-section of the Pilcomayo alluvial fan and river close to gauging station 2.

The Pilcomayo channel in the plains cuts itself through a mega alluvial fan of more than  $200,000 \text{ km}^2$  down to the Paraguay River, which is the largest of its kind on the eastern slopes of the Andes in South America. The whole of this huge area belongs to the Pilcomayo basin from an environmental point of view and yet it does not contribute to its flow, neither by tributaries nor by direct runoff. The land in the alluvial fan is very flat and sometimes the channel is perched at the fan top. Fig. 4 is one example of the few existing precise surveys across the fan, close to station 2 (see Fig. 1 for location), where one can see an abandoned channel at the fan top and the current channel at its right.

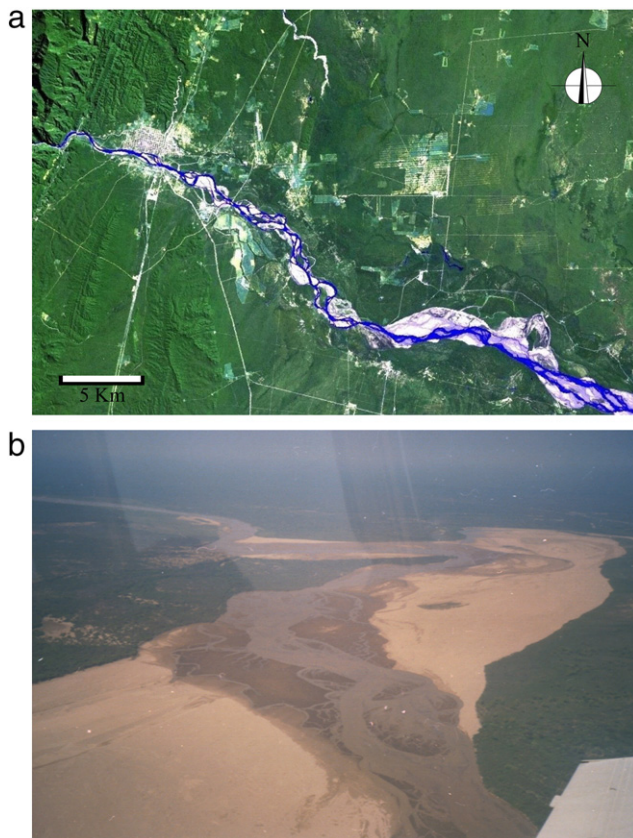
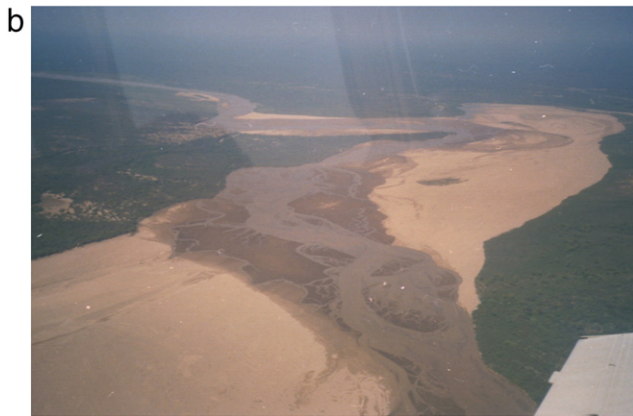
Fig. 5. Satellite and airplane photographs (flow from left to right and from foreground to background respectively) at the beginning of the lowland river. (For interpretation of the references to color in this figure legend, the reader is referred to the web version of this article.)

Focusing in the channel morphology moving in the flow direction, the Pilcomayo starts as a braided river issuing from its narrow valley of the last mountain range in the west, getting wider eastwards, as seen in the satellite photograph and the picture taken from the plane (Fig. 5). The pale-colored alluvial width, carved by the flow in the sand, can reach even 3000 m. The gauging station 1 stands inside the city at the left of Fig. 5, where the channel slope is around 0.12%.

Moving downstream, the channel gradually turns into a single thread meandering channel. Actually, its overall planform is meandering, with substantial in-channel bar features. Again, Fig. 6 shows photographs of the Pilcomayo from the satellite and from the plane in a region of the plains 180 km downstream of Fig. 5. The gauging station 2 stands inside the village at the right of the figure, where the channel slope is around 0.03%, the width is  $\approx 150 \text{ m}$  and the depth is  $\approx 3 \text{ m}$ . The channel is much narrower and natural cut-offs occur very often, even every year, as suggested by the oxbow lakes and how close the loop comes to being cut off in one point in Fig. 6. The extremely tortuous, uneven pattern of the meanders in Fig. 5, sometimes hairpin shaped, is unusual. An

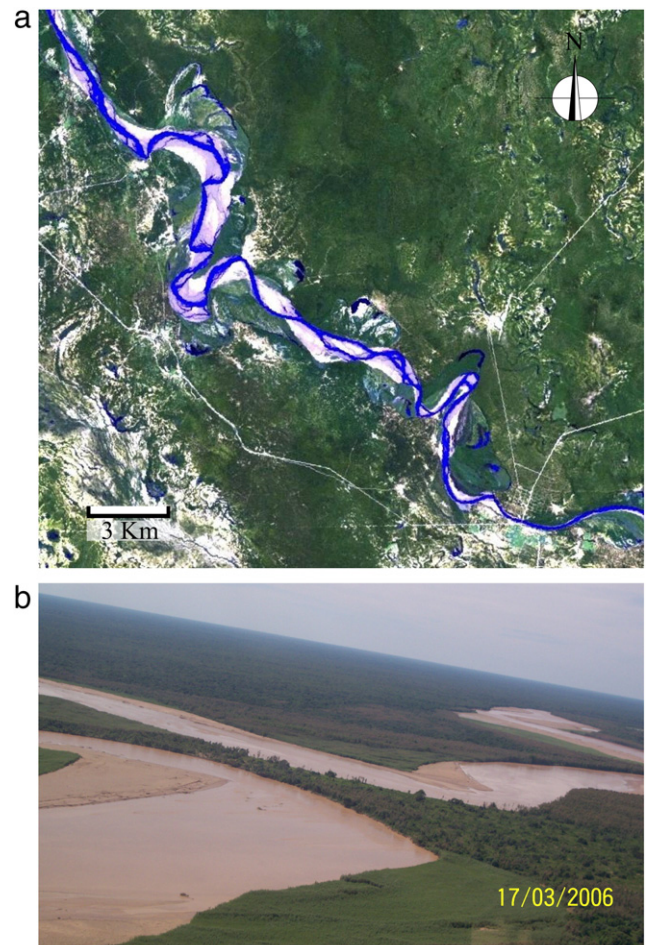
Fig. 6. Satellite and airplane photographs 180 km downstream of Fig. 2 (flow idem to Fig. 5).

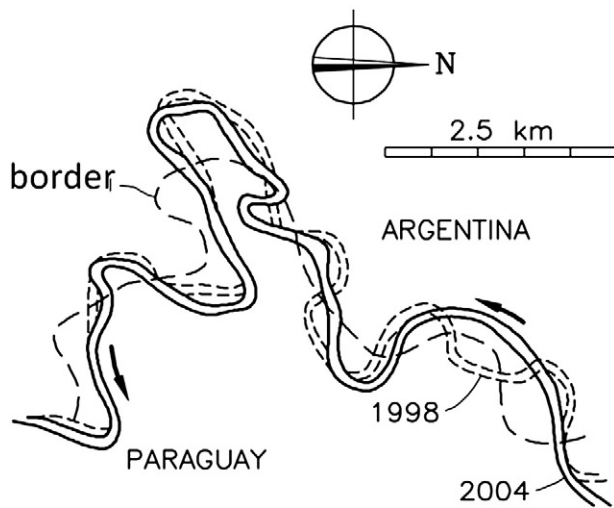
Fig. 7. River courses close to station 2 at different times. The border was set in 1945.

example taken from the region very close to station 2 is drawn in Fig. 7, where the channel has evolved crossing towards both sides of the border, which was set by an agreement in 1945.

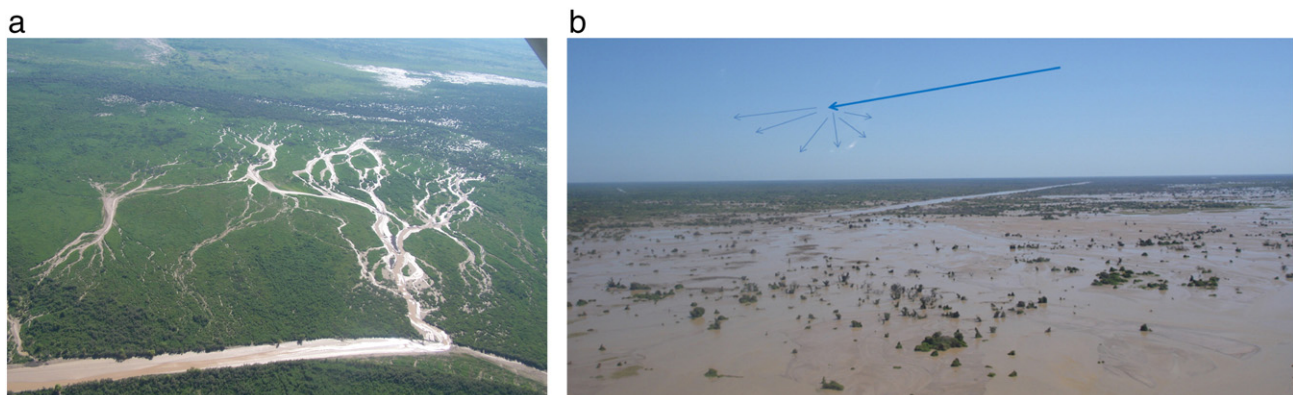
Fig. 8. Spilling at the jam in low (a) and high flow (b). Flow from left to right (a) and from background to foreground (b). The river is straight as explained in Section 4.

Moving a little downstream, the flow is suddenly obstructed by a jam of fine sediment and log or large wood debris that completely fills the channel, which is not able to convey the water any longer. In this paper, we use *collapse* in the sense that the blocked river *collapses* at this point. Instead of channel flow, water spills over the banks in front of the jam in a tree-like pattern of small furrows (Fig. 8a). In the flood season though, the channel and the plains are fully under water and

the flow is properly overland (Fig. 8b). In any case, this spilling and spreading across the plains feeds a large marsh area in the Chaco, a very complex system of seasonal lakes, swamps and slow channels, combining surface and groundwater flow, extending eastwards and finally draining clear water with no sediment into the Paraguay (Orfeo, 1999), which is not the topic of this paper. From the ground, the jam appears as in Fig. 9a — the comparison with a beaver's dam used in several reports is telling, in the sense that the tree trunks provide a framework

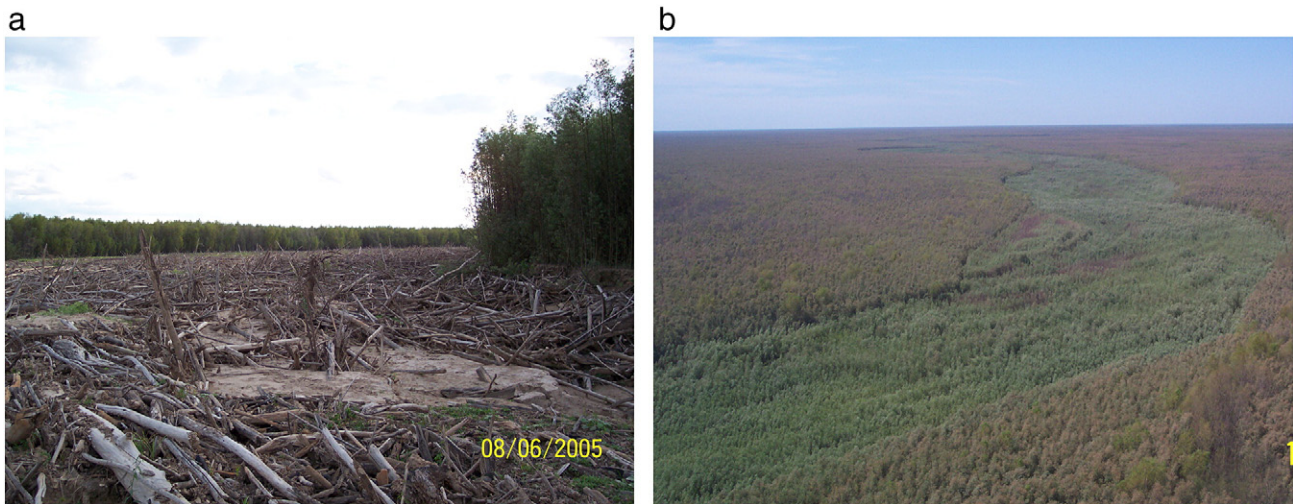
Fig. 9. View of the log jam from the ground (a). A channel colonized by vegetation one year after been abandoned (b).

which is filled with fine sand. The comparison may be misleading though because the jam at a particular stage is just the upstream-most tip of a channel clogged before by the same mechanism, not a single dam. Most of the wood comes from the tree *Tessaria integrifolia* (locally called Palo Bobo), very common in the Chaco Plains. It grows fast and spreads up to the river banks, being removed by bank erosion and colonizing the abandoned channels as well (Fig. 9b).

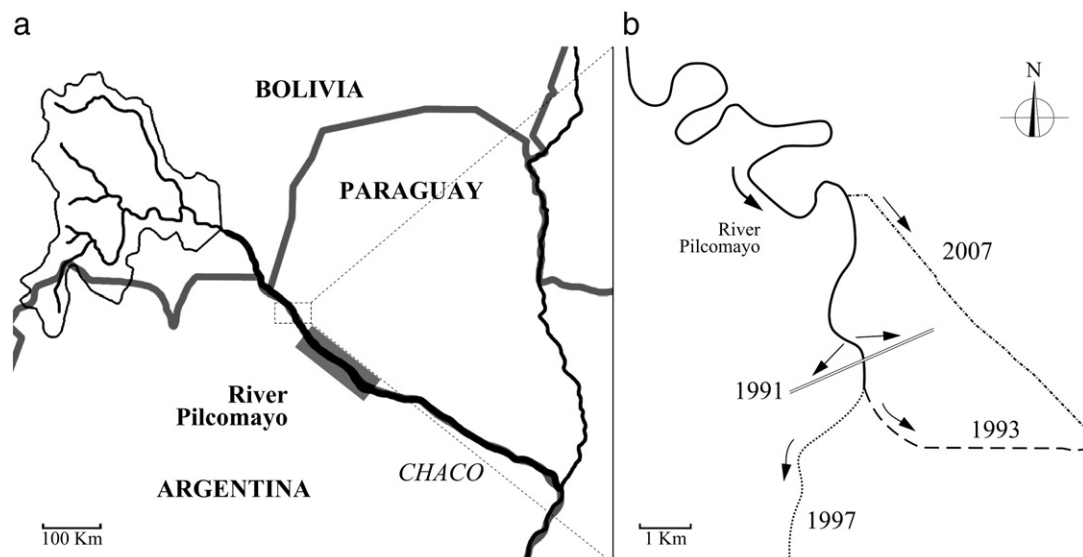
Fig. 10. (a) Channel length lost in 1976–90 (in bold line). (b) Canals dug by the two countries close to the point of collapse with the dates of construction.

The threat of losing the river urged the two countries to an agreement in 1991. They decided to dig a pair of equal straight canals (Fig. 10b), with the shared hope of a fair water distribution as well. So far since then, the two canals have not worked simultaneously for long, but when one has succeeded the other has failed, which seems to prove an intrinsic instability. Failure of a canal means it is completely silted (clogged) after only one or two flooding seasons. Success means to keep water flowing, but with large maintenance costs every year. This maintenance consists of removing much sediment and wooden debris from the canals and the jam and trying to maintain the gradient, sometimes by discharging in lower areas. The receding of the Pilcomayo, or rather the receding of the straight surviving canal out of it, has been stopped so far, thanks to this work of maintenance. On the other hand, the fair water distribution has proven impossible and the river flows largely in one country now – the luckiest regarding alluvial fan relief and/or the most diligent in canal work. Obviously, these last two drawbacks may contribute to

a mutual distrust. After failure, new canals have been designed by the countries ignoring the original agreement (Fig. 10b).

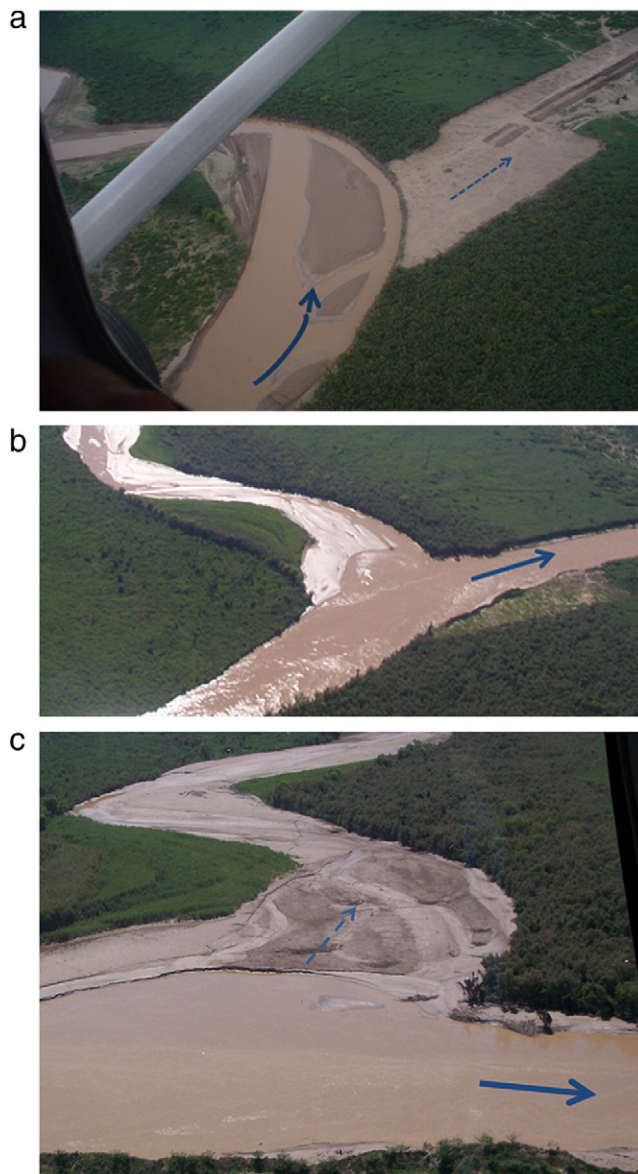
Fig. 11. Capture of the river by a canal in three pictures: November 2005 (a), February 2006 (b) and March 2006 (c).

The response of these canals was an opportunity for observations regarding morphodynamics in case of a large wash load, such as shown in the photographs in Fig. 11. In November 2005, before the rainy season started, the straight canal to the right was about to be finished (a). The existing channel was quite sinuous. In the high flow of February 2006 (b) flow occurred in both branches although some deposits seemed to emerge in the left branch. In March 2006, during the falling limb of the hydrograph (c), the old channel was silted and the diversion to the right had captured the flow of the river. The fate of the old channel is to be quickly colonized by vegetation (see Fig. 9b). Therefore, one single flooding season was enough for one canal to capture the river in this case.

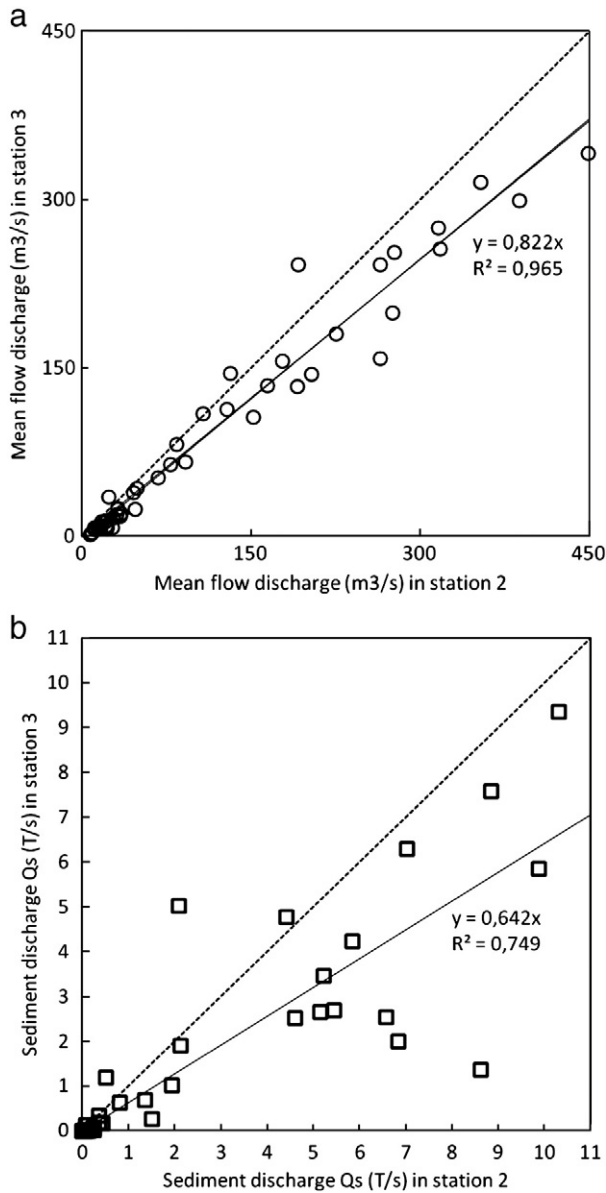
**Fig. 12.** a. Flow discharges expressed in monthly averages, at gauging stations 2 (upstream) in abscissa and 3 (downstream) in ordinate in the four years 1964–67. b. Suspended sediment discharges in monthly averages, at gauging stations 2 (upstream) in abscissa and 3 (downstream) in ordinate in the four years 1964–67.

Suspended sediment transport was measured at stations 2 and 3, 200 km apart, in the period 1964–1967 (four years), before the latter was caught by the river collapse. The mean monthly runoff  $Q$  and sediment load  $Q_s$  at stations 3 and 2 are compared in Fig. 12a and b.  $Q_3$  was well correlated with  $Q_2$ , whereas  $Q_{s3}$  not so well with  $Q_{s2}$ , as could be expected after the non-linearity and hysteresis of the  $Q_s$ – $Q$  relationship (see Fig. 3). Nevertheless, for more information the plot of  $Q_s$  versus  $Q$  for the four years of data in the two stations 2 and 3 is also given in Fig. 13 (the data are the same of Fig. 12, b but combined differently).

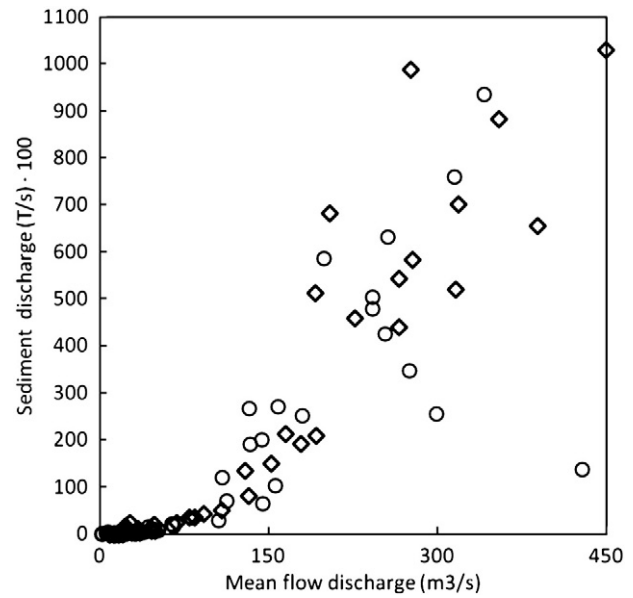
**Fig. 13.** Sediment discharge ( $\text{t/s} \times 100$ ) versus flow discharge ( $\text{m}^3/\text{s}$ ) for station 2 (diamonds) and 3 (circles) in the four years 1964–67.

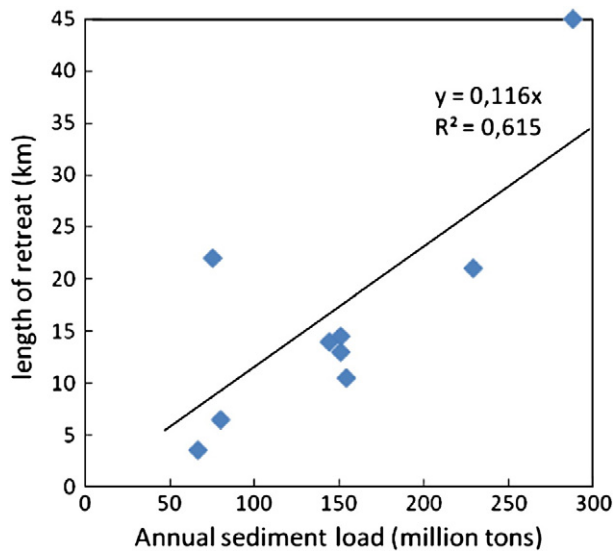
**Fig. 14.** Correlation between the length of retreat and the total suspended sediment load. Data from Table 2.

Furthermore, Table 2 compares the annual sediment load with the channel collapse location retreat. Among the nine years of data on retreat that are accurate enough, the year 1984 is outstanding because the load is double the average and the retreat four-fold the average. Fitting a straight line to these few data in Fig. 14, the correlation is

rather weak ( $R^2 = 0.62$ ), but its slope means an average retreat of 11.6 km per each  $100 \cdot 10^6 \text{ t}$ . Assuming again the size of the channel close to collapse as 150 m-wide  $\times$  3 m-deep and a specific weight of  $2 \text{ t/m}^3$ , this length of retreat means that the channel takes to fill itself a share of 10.3% of the total load. This figure is very similar to the estimate of the previous two paragraphs. In summary, some 10–12% comes out as the fraction of the total load which is not wash load (after grain size) and, also, as the fraction of the suspended load settled within the channel (after a sediment balance and from the retreating channel geometry, as well).
